Fethard Historic Town Walls County Tipperary

Conservation & Management Plan

Oxford Archaeology
June 2009

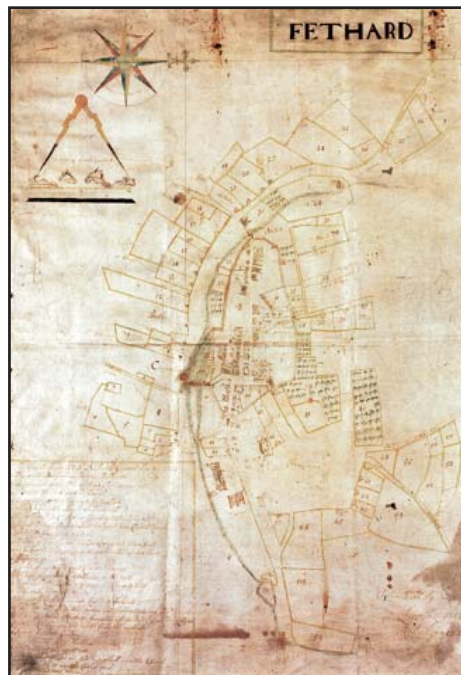
Figure 3: Grace's map of Fethard 1709

The North Gate is an arch flanked by a tower, and the lost Madam Castle at the west gate was a large double tower over the gate, and it may well be that the lost gates also had adjacent towers or 'castles'. The group of urban castles around the churchyard are ostensibly individual palaces of great urban families, though the one in the church yard wall may have been a 'vicar's pele' like those of northern England. Whether Court Castle and Edmond's castle could have functioned as adjuncts to a collegiate church is an intriguing possibility.

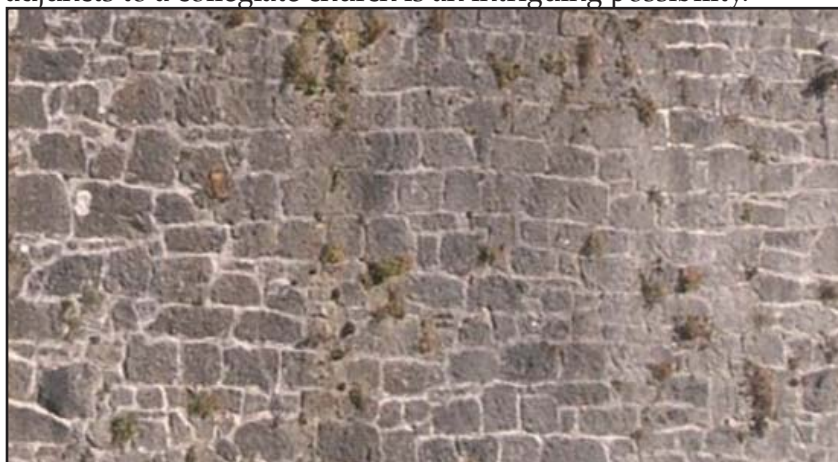
Figure 4: Example of Fethard masonry on SW mural tower

There are few diagnostic features in the masonry fabric to determine dating, apart from the late-medieval style of parapets (and the single arrow-loop by the water gate), and it is not certain that the arch of the North Gate is medieval. One characteristic features is the masonry walling, which is remarkably consistent in most standing lengths of wall. This typically consists of large squared (or rather polygonal) blocks, laid in regular, though not usually horizontal courses. This is quite distinct from coursed rubble or level coursing of squared blocks, and the fact that the characteristic regularly/irregular masonry can be seen in most of the standing remains suggests that they may be contemporary.

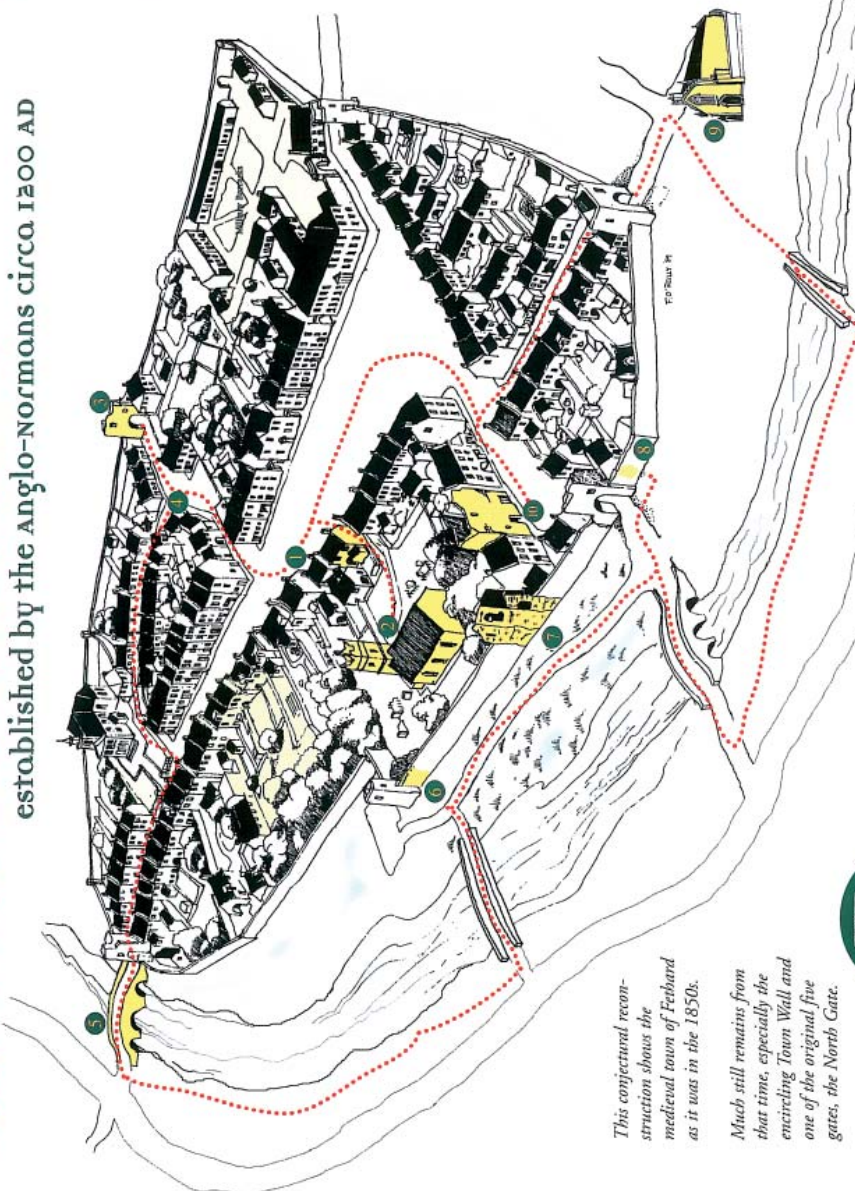
The North Gate (also known as Sparagoleith), is the only surviving gate of the five original gates in the town wall. On the underside of the archway are markings left by the wickerwork which was used in its construction.

This conjectural reconstruction shows the medieval town of Fethard as it was in the 1850s.

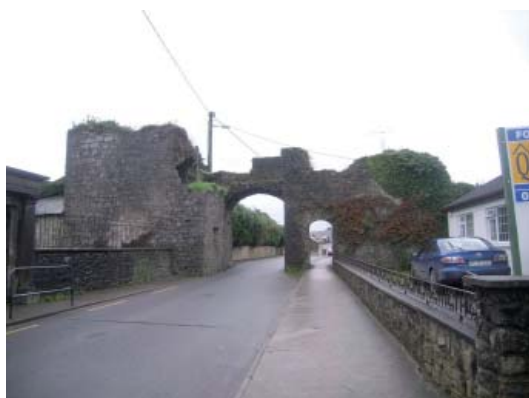
*The North Gate and
Currikeen Castle*

The North Gate is the one surviving gate in the Town Walls, at the mid-point on the north side of the town. Part of its adjoining castle also survives.

- Vegetation growing on the North Gate and especially the Castle needs to be checked and removed if damaging the stonework.
- Inclusion of site into a central town interpretation.

- Potential for improved access to tower, possibly with provision of stair and railings to first floor.
- Potential siting nearby of an information board with history of site (danger from traffic to pedestrians needs to be considered).

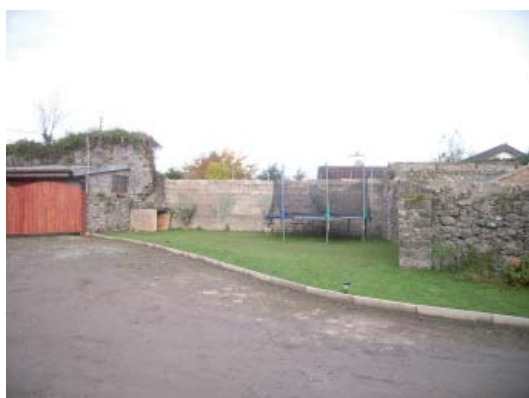
- The vegetation and trees growing on the wall need to be identified and the growth of any species destructive to the wall should be stopped. All removal of vegetation and roots should be carried out without causing further damage to the wall.
- The breach in the wall which has been filled using breeze blocks provides the potential for a further access through the wall into the town by their removal. As the land is in private ownership permission for such access would need to be obtained.

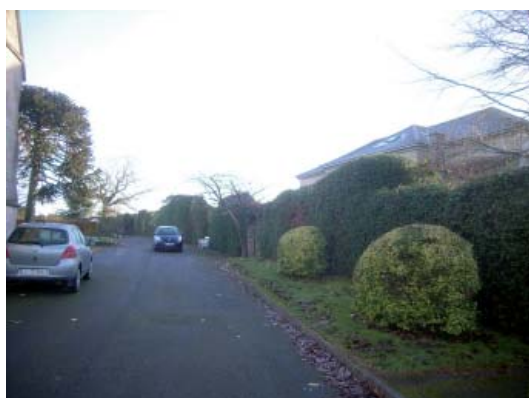
2.03

- Identification of types of vegetation is required and any destructive species removed using methods which will not cause damage to the wall fabric.
- There is no public access to the wall. The Convent has a large section of wall within its ownership and if permission could be obtained from them for access, visitors would see an area representative of the complete town wall.

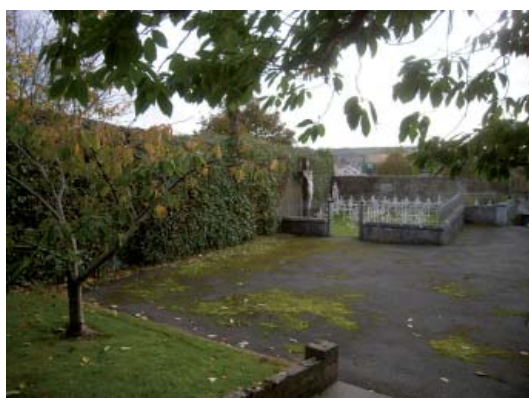
2.04

(b) Area west of the convent entrance (Fig 3) - good.

(c) Area east of the convent entrance and within the enclosed garden (Fig 3) – good.

- This section is presently in the ownership of the convent but any future sale of the land may pose risks to the wall from development generally and groundworks in particular.
- The view of the wall, apart from overgrowth directly on it, is now visible and not obscured by buildings and steps should be considered to protect it from future encroachment.
- Vegetation covering the southern part of wall probably causing loosening and deterioration of the masonry and is obscuring the actual condition and nature of the surviving structure.

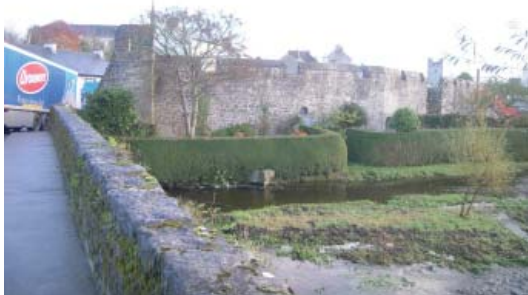
Wall south east of Madam Castle

- Further investigation into the current condition of the parapet (in particular for Health and Safety aspects) and the possibility of developing a visitors' tour along the wall walk.
- A commitment to continued maintenance of the wall.
- Enquiries into the possibility of the current owner permitting visitors to view the wall at close quarters (although a clear distance view of the wall is easily obtained from Madam Bridge).
- There is no pedestrian access through the wall or from the south of the river between Madam Bridge and the new bridge.
- There is no access to the interior of the wall and Madam Castle.
- The area of the town from south of the river is very pretty and the gardens at the foot of the wall at Madam Bridge enhance the view.

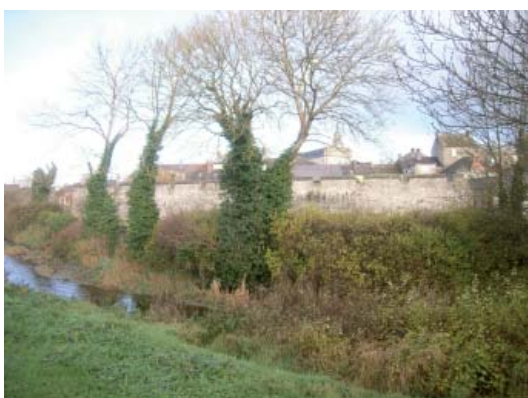
2.08

- The view from the south is partly obscured by overgrowth of trees and seedlings which need thinning.
- Consideration could be given for access for the public south of the river to obtain a view of the complete southern section of the wall.

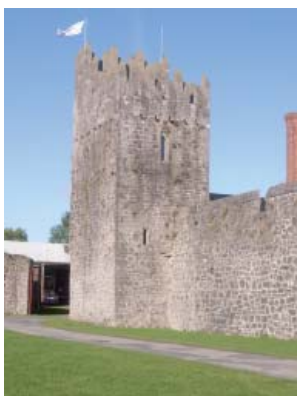
2.13

- The west ground floor doorway is insecure posing potential problems of vandalism and health and safety issues. Measures need to be put in place to prevent trespassers entering the tower, wall walk and churchyard. However, this tower entrance is within the privately owned garage compound of buildings west of the tower which is secured with a locked gate when not in use.
- 1991 excavations revealed further evidence of walls. Any future groundworks should include a programme of archaeological investigation.
- Any further building works should include a programme of building recording.
- Any public access would require permission to enter the garage premises.
- Public access would be subject to the entrance and ground floor being made safe.

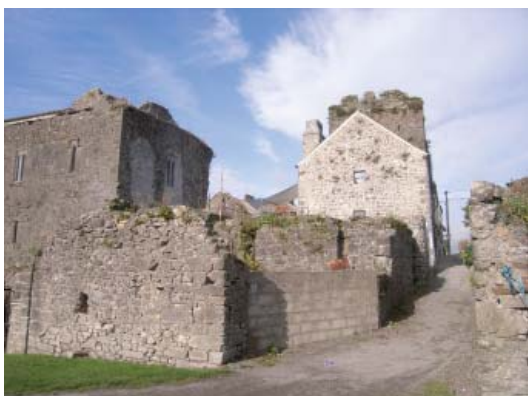
2.17

- Edmond's Castle is in private ownership and not currently available for public access.
- The land inside the ruined building south-east of Edmond's Castle is overgrown and needs clearing. If the external building was removed the full extent of the town wall could be better seen from the outside.
- The town wall and walls of the ruined building are overgrown and removal of the vegetation is needed, and masonry repairs.
- The recreation of the wall linking Edmond's Castle to the gap for the roadway could be part of a major enhancement of this area, completing the previous phase of the restoration from Madam's Bridge to Watergate Bridge.

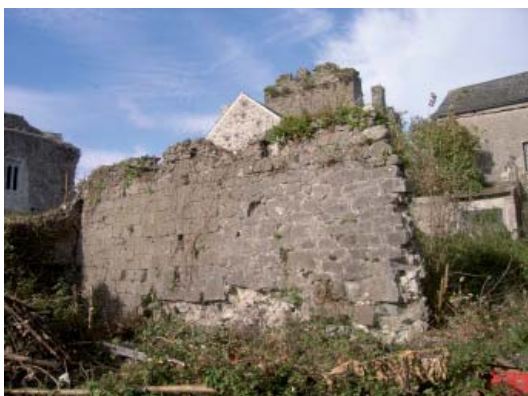
Gazetteer 2.18

Condition (exterior) - Visibility of this section of wall is obscured by dilapidated sheds, enclosing walls and large amounts of rubbish. The walls themselves are in a poor state and are in danger from tree roots growing at the base. There are large cavities at the base of the wall almost all the way across and an access way has been knocked through in the centre. To the right of this the lower part of the wall has fallen away to such an extent that the facing on the other side is exposed. The top of this wall has been partially rebuilt to form a gable for the sheds and it appears to be very structurally unsound and in need of urgent repair. The section of wall to the left of the access way has also been partially rebuilt at the top but this also is in poor condition and much of it has crumbled away.

Condition (interior) - The left side of this wall has been built up a further 2m to form part of a gable for dilapidated out-buildings which obscure its visibility from outside. Access to this part of the wall is very much restricted by large piles of house-hold rubbish which have been dumped against it. The wall in the interior of the building has been lime-washed but it is in questionable condition and may need to be re-pointed. The part of the wall outside this building is in poor condition as all of the facing has fallen away. There is a tree growing directly out of the wall and there are concrete breeze blocks and other debris piled against the bottom. The wall has been knocked through in the centre to provide access to the back yard of the property. On the right side of this access-way, there is a tree growing against the base of the wall and it is likely that its roots are affecting the buried part of the wall. The top of the wall appears to have been topped with concrete at some point but most of this has fallen away along with some of the stones. There is a small window feature at the top of the wall which is at risk from ivy growth. There is an old oil tank and a large pile of vegetation against the wall at the right side and there is a cavity in the wall where the dividing wall abuts it. It is very likely that there is a large amount of stones from the wall lost in the debris on the property and a careful investigation may be necessary during any future clean-up of the area.

- The condition of the exposed ends of the walls either side of the gap and the north and south faces should be assessed and minimal repair works carried out as necessary. These should maintain the integrity of the Medieval structure.
- If the land to the south of this section of wall was tidied and cleared the southern town wall could be viewed in its entirety from the south. The land is in private ownership therefore the owner's co-operation would be required.
- Vehicles are being driven and parked on the grassy area to the south of the town wall and consideration could be given to physically restricting vehicular access of the road

- Continued commitment to the maintenance of the walls.
- A walled yard and building to the south of 2.18 at the river's edge is currently disused and in private ownership. Apart from this yard the area south of the wall is open space and a clear view of the town walls from the south and medieval bridge is potentially available, if this land was dedicated to public open space.
- The repair of this wall, and closing of the breach, together with the recreation of the wall to the west could be part of a major enhancement of this area, and completing the previous phase of restoration along the south walls. The metal shed leaning against the wall should be removed.

This wall has now in part been repaired.

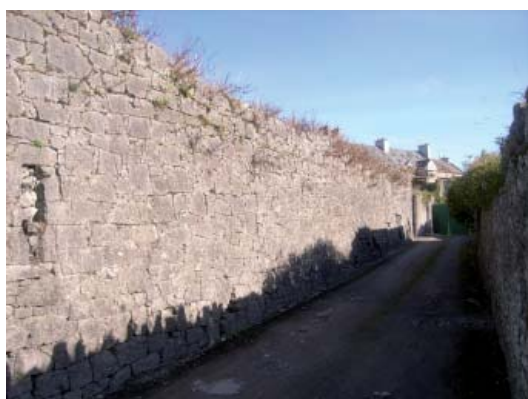
2.21

Condition (exterior) – Large areas of exterior facing have fallen away exposing the rubble interior. Previous attempts to repair the wall with stone and cement have failed leaving large loose stones. It is necessary to remove the concrete and cement from the walls before repairs are carried out.

- Commitment to preserve the remaining wall structure.
- The safety of visitors to the wall in this area should be considered as access is via a road.

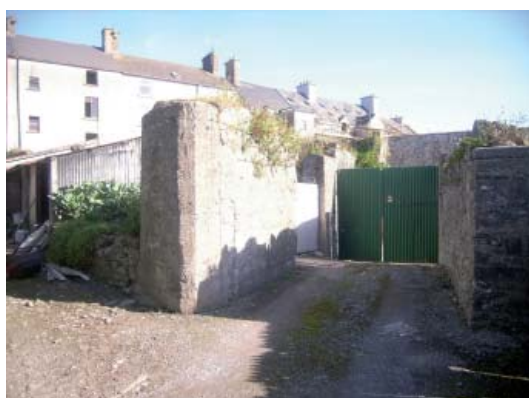
2.22

cement which may cause problems in the future. There are stones missing from the top of the wall and some plant growth but it is otherwise structurally sound. The second section has a large area of patching with stone and cement on the lower half of the wall. Where the wall ends, a shed made of concrete has been built on to it.

The interior of this section of wall is in very bad condition. The facing is almost completely gone and large chunks of the rubble interior have fallen away creating a concave surface. The wall is at risk from damages caused by the building materials leaning against it.

- Commitment to preserve the remaining wall structure.
- The safety of visitors to the wall in this area should be considered as access is via a road.

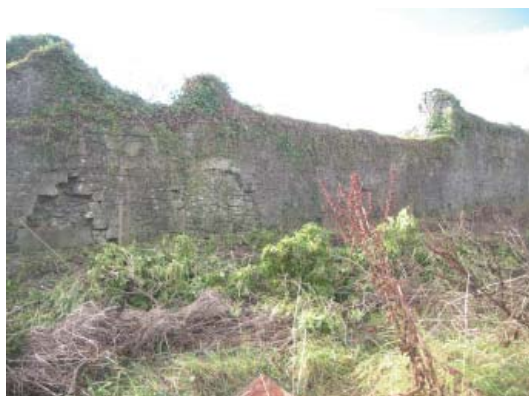
2.28

There are small areas of plant growth along the top of the wall but the wall is otherwise in very good condition and structurally sound.

This sector of wall has now been repaired in an exemplary manner.

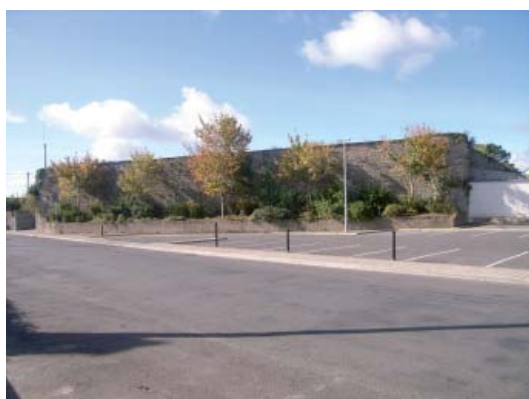
2.33

- A number of trees have been planted along the exterior of the town wall and unfortunately as the roots of these grow towards the wall they will undermine and damage it. The trees need to be removed, perhaps replaced with a flowerbed.
- The Mart is still in use but outside the opening hours of the Mart the area is locked. It is not open to the public and the interior of the town wall is not generally accessible.
